2018 Data Report for

Tamarack Lake, Livingston County

Site ID: 470610

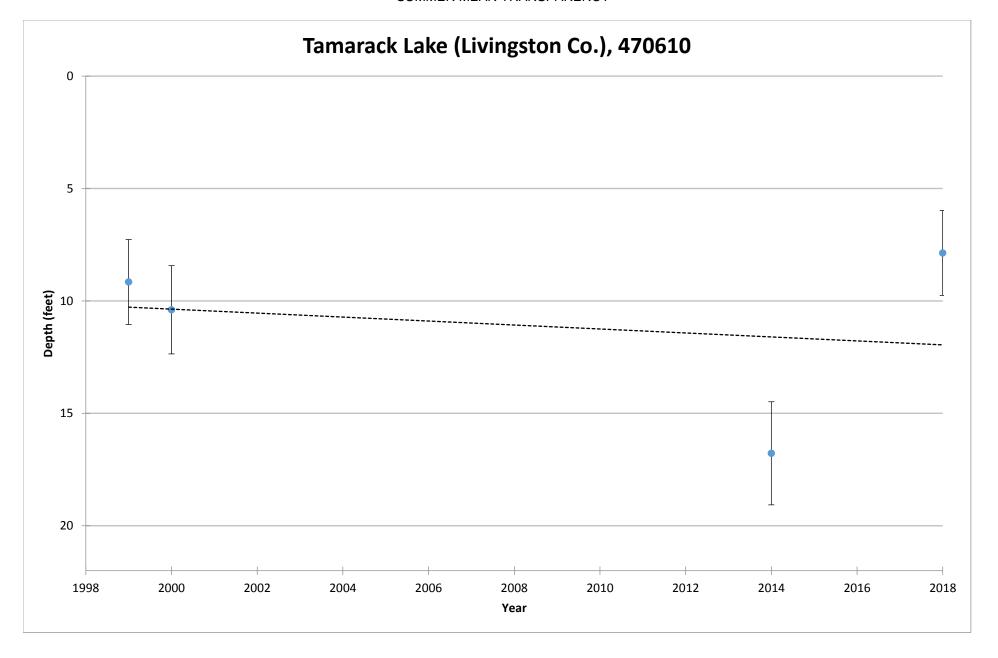
COOPERATIVE LAKES MONITORING PROGRAM SUMMER MEAN TRANSPARENCY

Year	# Readings	Min	Max	Average	Std. Dev	Carlson TSI
2018	15	6.0	12.0	7.9	1.9	47
2013-2017	24	8.0	19.0	7.9	2.3	36
1999-2012	38	7.0	14.0	9.8	1.9	44
2018 All						
CLMP Lakes	3392	0.5	94.0	12.6	2.7	42
